Geologists assist in TMI-2 core assessment

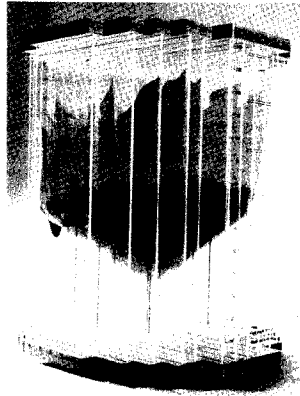
A TRANSPARENT PLASTIC model of the core as mapped by geologist Dick Smith was built by David Sharp and Craig Walker of EG&G Graphics. On the lower left of the mass, shown by a small dark area, is the location of the "breakout."

Initially, it was expected that "breakout" would occur at the core center since heat was symmetrically distributed in the core and, should a significant fraction of the core become molten, material would flow out of the bottom in the center to the lower plenum of the reactor vessel. The big surprise was discovering that it did not follow this expected path but instead penetrated the top or side of the crust of agglomerate and flowed down near the southeast periphery of the reactor.

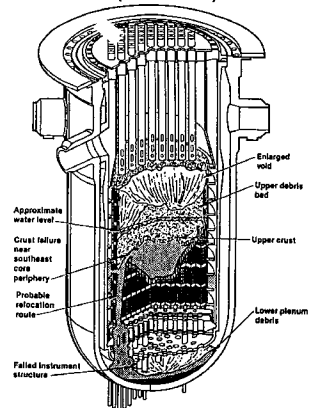
Hypothesized Core Damage Configuration (226 Minutes)

From videotapes of the drilled holes, Smith was able to put together vertical cross-sections showing the different types of material. Two major zones were identified in the lower portion of the damaged core: an outer agglomerate of previously molten fuel material surrounding unmelted fragments of partially intact fuel pellets and an inner zone of previously molten homogeneous ceramic interlaced with metallic stringers. Melting of this ceramic material requires a minimum temperature of 4580 degrees Fahrenheit and in some cases as high as 5120 degrees Fahrenheit.

THE ABOVE DRAWING shows the hypothesized core damage configuration determined from the videotapes and the geologists' work.
